Asset Care Counts

Taking the guesswork out of managing resonance issues using FEA

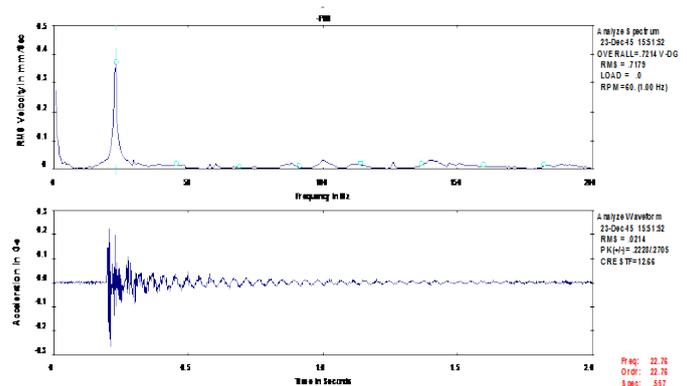
A bump test performed on the fan structure revealed a clear resonance at 22.8 Hz.

Figure 1: Bump Test Spectrum and Waveform

Multichannel data-acquisition revealed that the resonance related to a whole body horizontal vibration mode, resulting in specific distortions of the motor support structure, fan casing and mounting skids.

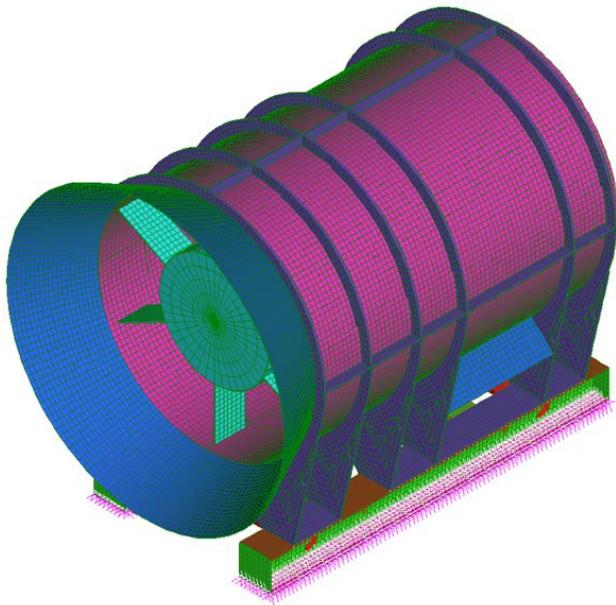
With this information gathered onsite, ALS set about constructing a finite element model to test a number of different structural modifications aimed at altering the resonant frequency.

Figure 2: Ventilation Fan Finite Element Model

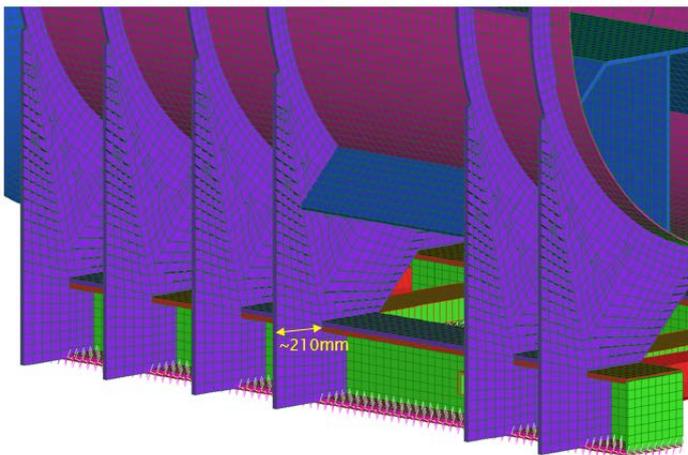
Figure 3: Finite Element Model Showing Stage 1 and 2 Modifications

The final solution was designed in three stages to meet immediate and future performance requirements.

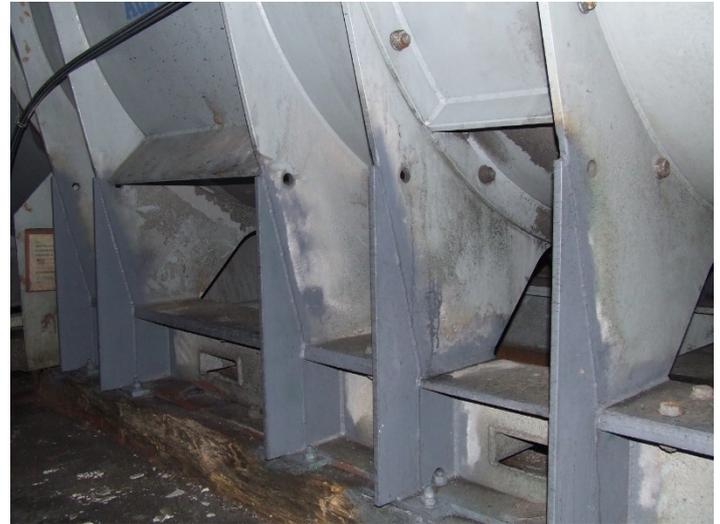
Figure 4: Modified Underground Vent Fan Structure

After implementation of stages 1 and 2, ALS attended site to perform, ALS attended site to perform further services only to find fan already operating at low vibration levels and not requiring any further improvement in balance state.
