Asset Care Counts

August 2014

## Condition Assessment of Cast Iron Cement Lined Pipe

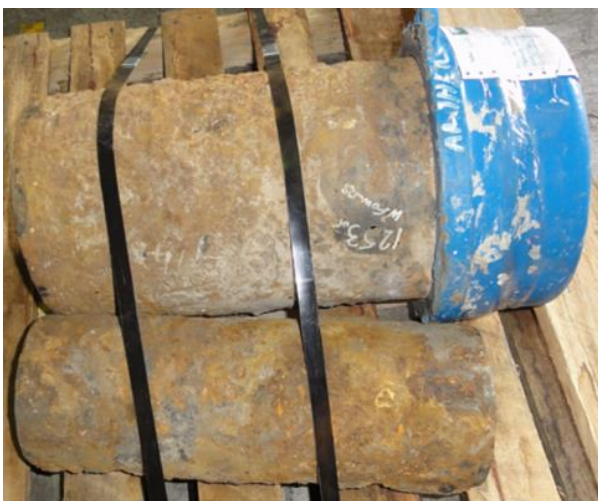
Figure 1 – Pipe samples analysed

ALS was able to assist our client via undertaking a conditional assessment on a buried CICL pipe laid in the early 1950's. Cement lining thickness, remaining protective alkalinity of the lining and the nominal thickness of the cast iron (and loss of thickness from graphitisation) was determined on two supplied samples.

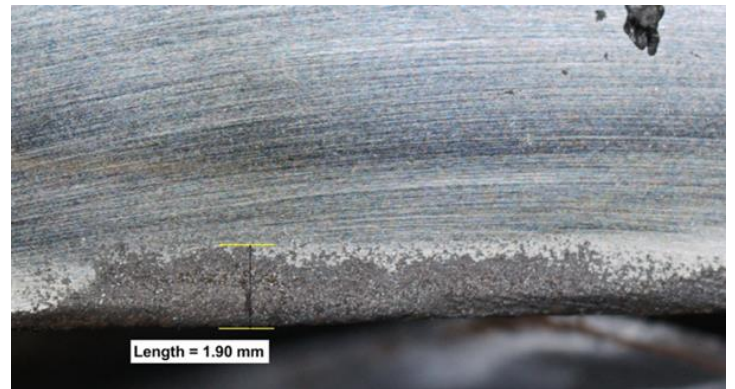
Figure 2 – Micrograph showing depth of graphitisation

The existing methodology, to measure the depth of graphitisation and thus remaining thickness of pipe, is to physically examine a cross-section microscopically, or by removing the graphitisation by mechanical means and then measuring the remaining wall thickness.

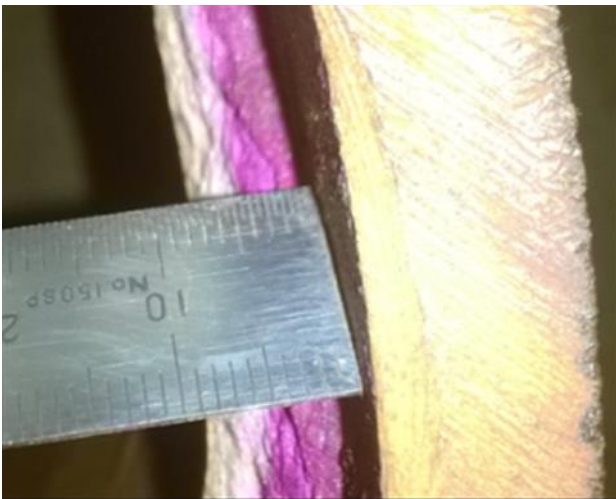
Figure 3 – Measurement of the concrete lining showing loss of alkalinity

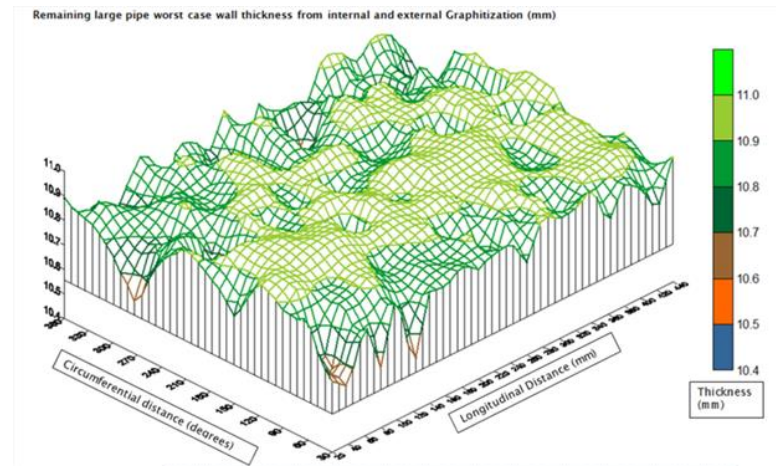
Figure 4 – Isometric plot of the remaining wall thickness

ALS has developed a graphitisation thickness measurement technique using magnetic induction that is able to measure the depth of graphitisation. As there is often variability in the degree of graphitisation, partial degradation is determined by correcting against a calibration cross-section.

This innovative conditional assessment was able to show the state of this timeworn pipe, particularly the extent of graphitisation on the external surfaces of the pipe. The results enabled the client to gain an appreciation of the remaining service life of their asset and make appropriate plans for its upkeep and maintenance.
