AssetCare Counts#10

November 2011

► Microbial Induced Corrosion detection in Piping and Pipelines

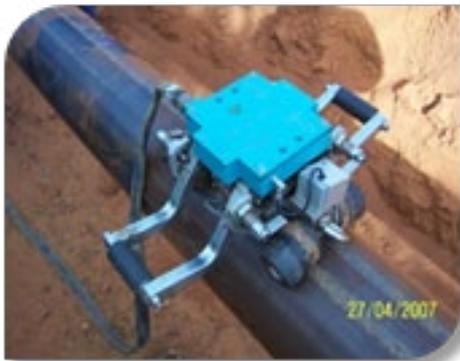
**SLOFEC pipe scanner
positioned on pipe**

ALS have developed a special approach to the detection and measurement of this damage mechanism. This includes the use of our SLOFEC technology as a screening tool followed up with manual ultrasonic measurement.

The piping is scanned using the SLOFEC technique, which effectively detects the MIC pitting, allowing ALS to focus the manual UT survey achieving reliable and accurate results.

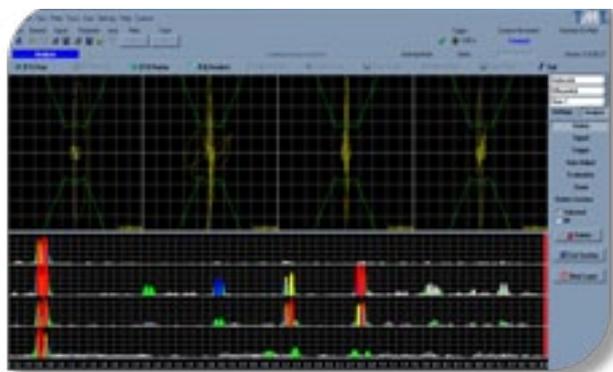
Screen display showing SLOFEC data

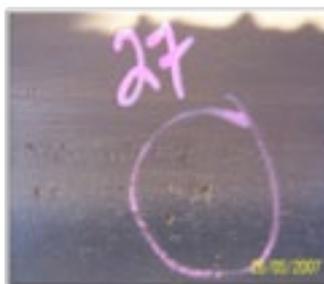
Typical MIC pit

Microbial Induced Corrosion (MIC) is an increasing problem as assets age. This type of damage mechanism can result in a variety of defect configurations, but is generally in the form of small diameter very deep conical pits that can be found anywhere in the pipe. Because of this, it is extremely difficult to determine where the damage is likely to be worst. In addition, the growth rate of MIC defects can vary dramatically depending on localised conditions, so the better the inspection strategy, the more reliable predictive maintenance and future integrity management plans.
