### **Innovation and Creative Thinking Satisfies a Critical Inspection Task**

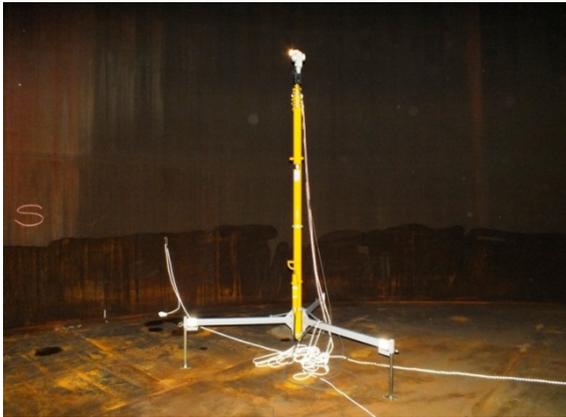
Figure 1: : Telescopic pole in lowered position

The telescopic pole is taken into the tank through a standard access manway and can be easily and efficiently erected by no more than two people. The pole has a high resolution camera attached to the top of the pole as well as a high power light source. The camera is manipulated from the ground and can be steered to focus on any part of the tank required. Images are viewed on a laptop computer and photographs are taken as required and stored for inclusion in the inspection report. The telescopic pole is moved around the tank to

ensure full coverage of the internal structure. When fully extended the telescopic pole reaches approximately 30 meters in height.

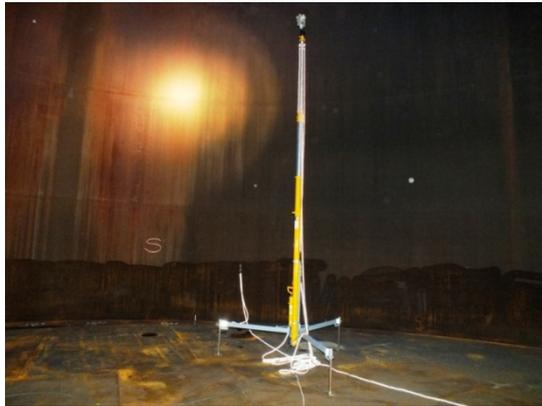
Figure 2: Telescopic pole partially extended

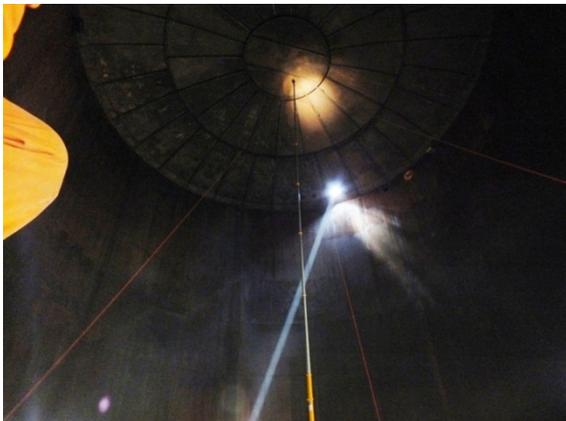
Figure 3: Telescopic pole fully extended, to the top of the tank roof

Guide ropes are used to attach the pole to the tank wall or floor using magnets. This ensures that the camera at the top of the pole remains still so that clear, accurate images of the structural condition can be recorded.

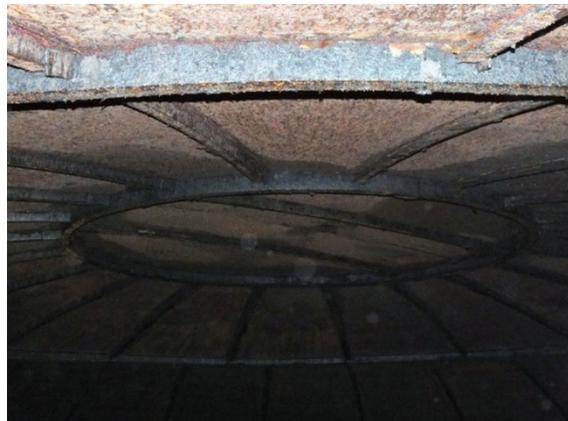
Figure 4: Image of roof structure, showing mild corrosion

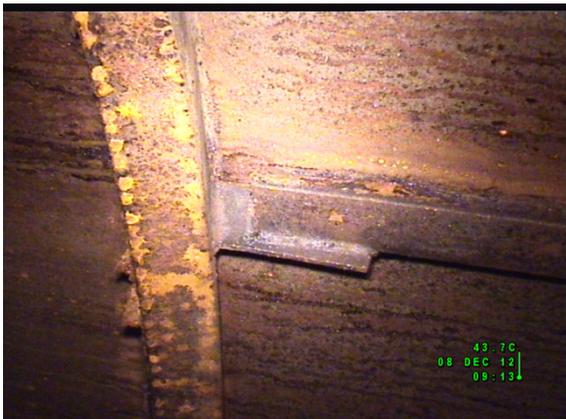
Figure 5: Image of side wall showing mild corrosion
