Asset Care Counts

Understanding the Condition of Your Critical Bolts

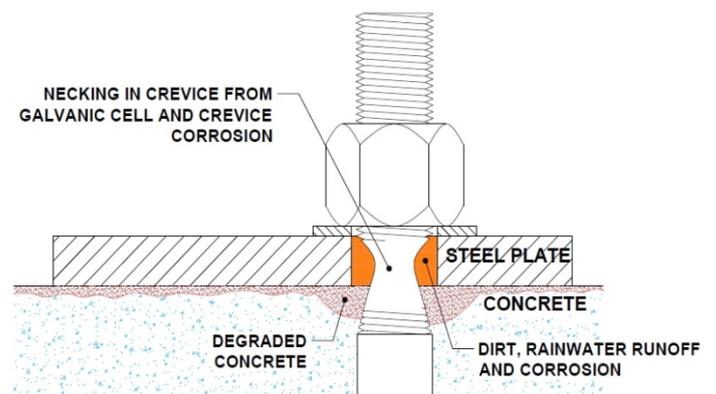
Figure 1 - Typical corrosion necking of an embedded steel bolt

Other mechanisms i.e. cracking in the thread area can in most cases be found using normal zero degree pulse echo ultrasonic techniques, however corrosion related failures mostly occur at the concrete/air interface as well as in areas where the concrete has degraded, and area up to 300mm in depth from the bolt end. (see Figure 1 below). These areas require a totally different inspection approach.

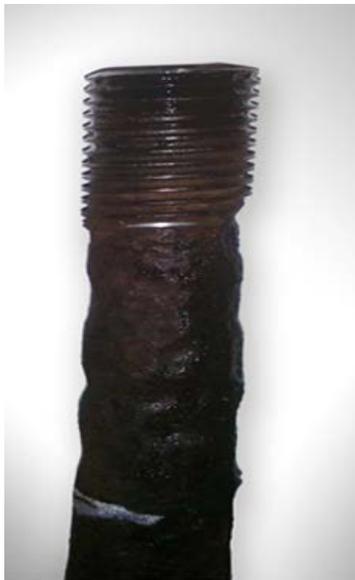
Figure 2 – Corroded Bolt Inspection by PAUT

Phased array UT provides an improved solution over traditional ultrasonic scanning. The probe array provides a multitude of signals which are decoded to create a representation of wall thickness loss in the bolts where manual ultrasonics fails.

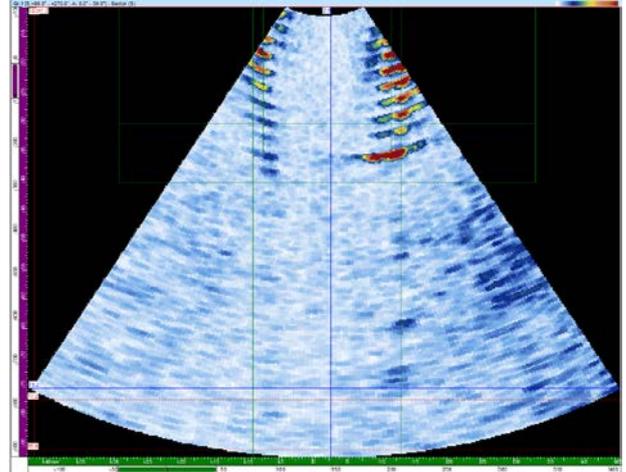
Figure 3 – PAUT image showing the location of threads and artificial defects for the purpose of this test. The technique represents an excellent screen
